TECHNICAL FINAL REPORT

LANDSLIDE HAZARD ZONATION BETWEEN NONEY-NUNCBA ALONG NH-53 AND GEOTECHNICAL INVESTIGATION FOR TWO SLIDES

**MANIPUR SCIENCE & TECHNOLOGY COUNCIL
CENTRAL JAIL ROAD, IMPHAL-795001**

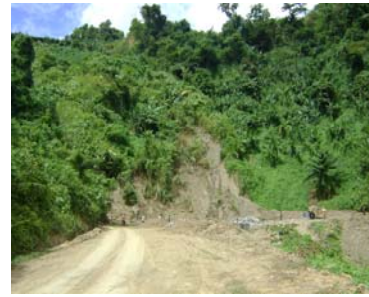
A circular type of landslide has been occurred at Awangkhuul Part-II ( $93^{\circ}31'15''$  E and  $24^{\circ}49'29''$  N) along **NH-53** which is about **26 km** away from Noney with an area of about **0.021 sq.km**. This type of failure often occurs on hill slopes characterized by overburden soil and debris. The landslide damaged the road over a distance of about 100m, where it slides down by a vertical height of about 86m. The slide has been observed on 17th September 2008 during field survey.

*Landslide at Awangkhuul Part-II*

The rocks in the slide area are occupied by the **Barail Group** of rocks. The Barail Group are characterized by alteration of sandstones and shale showing intercalations sometimes thickly bedded sandstone beds showing typical turbidite character at places. However the landslide occurred on a slope about  $35^{\circ}$  predominantly consisting of soil debris accumulated on the surface of the hills. The major reason of the landslide is both **anthropogenic** and **natural** causative factors.

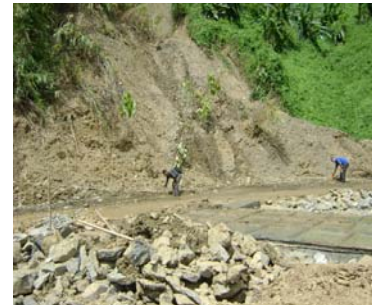
*Closure view of the Slide*

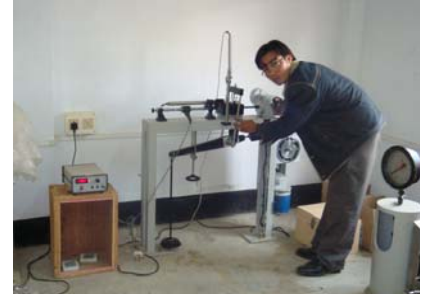
Stress Strain curve of the soil samples of the landslide site are made by plotting the data of displacement against load calibrating from Direct Shear Test

*Analysis of Soil Sample (Direct Shear)*

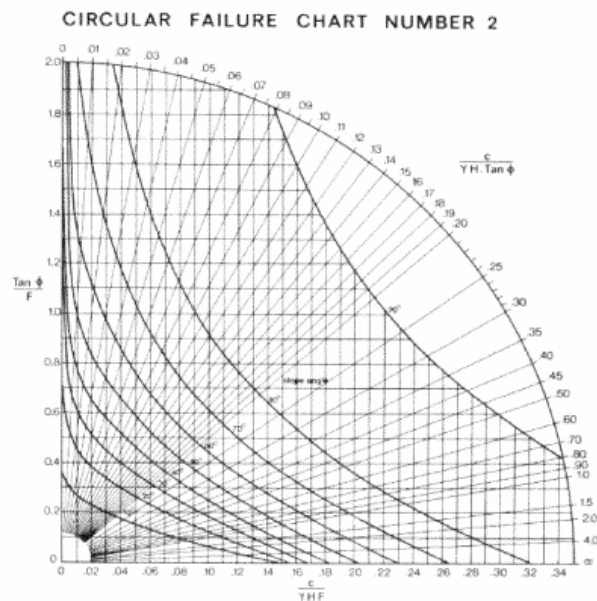
The soil samples were collected from three different heights of slided mass. They were mixed thoroughly to get a collective representative of the entire mass. In laboratory, this was again divided into three equal proportions and weight of individual part was noted. Then they were heated in hot oven for 24 hours after which their individual weight was again noted. The difference in weight gave moisture content of the samples and this value could be used to choose a particular chart to be considered for groundwater flow condition. The moisture content of this area ie. Awangkhul Part-II is **20.81**. So, the Circular Failure Chart of **25%** groundwater condition has been choosing for the derivation of Factor of safety (F).

Fig 6: Circular Failure Chart for 25% groundwater condition

This value is marked on the peripheral arc (outer circular scale) of the failure chart for the corresponding groundwater condition. The radial line from the outer circular scale is then followed to the particular curve for slope angle ( $40^\circ$  as in this case).

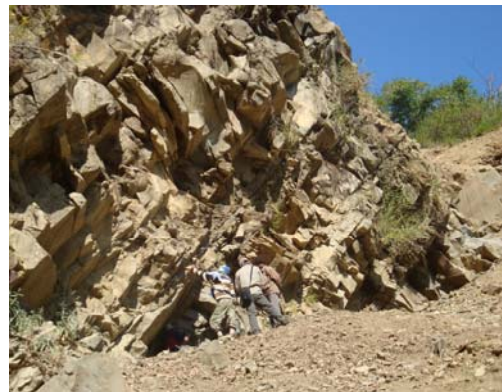
A landslide has been occurred at Raungdai/Blongdai ( $93^{\circ}26'29''$  E and  $24^{\circ}46'19''$  N) along NH-53 which is about 4 km to Nungba. The area is characterized by intercalations of shale and bedded sandstone. The general slope is N  $129^{\circ}$  strike and  $36^{\circ}$  S Dip. The landslide damaged the road over a distance of about 120m, where it slides down by a vertical height of about 100m. The slide has been observed on 31st December 2008 during field survey.

*Landslide at Raungdai*

After kinematics analysis of the orientations of discontinuities and field observations of the sliding site, the Raungdai/Blongdai landslide has been identified as Wedge failure. Wedge failure is a type of transitional failure that occurs on rock slopes. When geological discontinuities are unfavorably oriented with reference to general slope. In case of wedge failures, two discontinuities strike obliquely across the slope face with their line of intersection getting daylight on the slope and the rock wedge formed due to this intersection will tend to slide down along the line of intersection, provided that the plunge of line of intersection is less than the slope inclination and greater than the angle of internal friction.

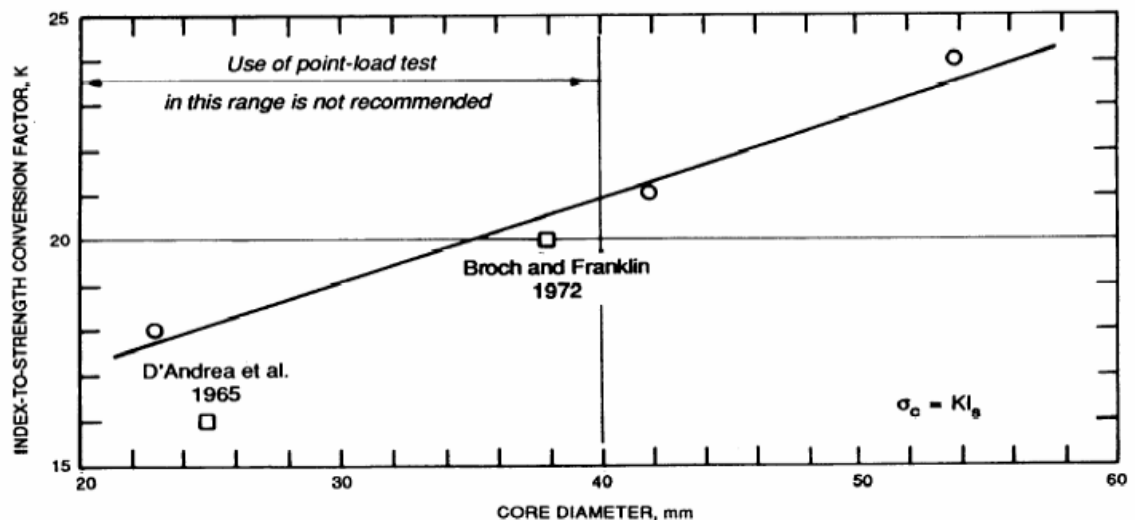
Where K is the "conversion factor." Broch and Franklin reported that for 50 mm diameter cores the uniaxial compressive strength is approximately equal to 24 times the point load index. They also developed a size correction chart so that core of various diameters could be used for strength determination. Subsequent studies found that  $K=24$  was not as universal as had been hoped, and that instead there appeared to be a broad range of conversion factors.

Fig 10: Size correlation graph for index-to-strength conversion (after Bienawski-1975)

The correlation of  $I_s$  with UCS is both material specific and size dependent. Therefore, for best accuracy this correlation should be established for each site specific material. In this case, a number of UCS tests would be necessary, but the time and cost savings for large numbers of strength tests would be significant using the point load tester. On the average, UCS is 20-25 times the point load strength (**ISGO**), but can vary over a much wider range (ISRM 1985). Where site specific correlations or other material-specific information is not available, the UCS can be found using the size correlation graph (Figure 1) to obtain the index to-UCS conversion factors. For example, a conversion factor of 23 is found if using the common NX (54 mm) core size. Point load tests on igneous and the harder sedimentary rocks could be expected to have a reasonable correlation with UCS using factors close to those given above. However, the weaker rock materials, which are typically dredged by mechanical means, may require a lower correlation factor. The limited point load and UCS tests performed to date on weaker dredged material indicate an average correlation factor near 20. Correlation was certainly well within the variability of the material even using a factor of 23 for the (NX) sized core.

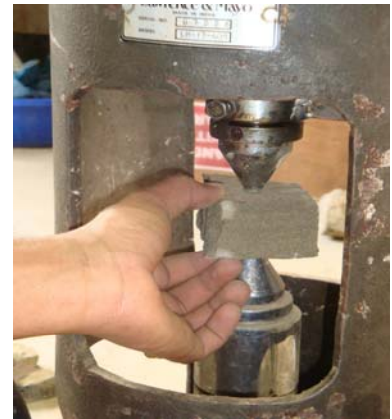
Point load testing is used to determine rock strength indexes in geotechnical practice. The point load test apparatus and procedure enables economical testing of core or lump rock samples in either a field or laboratory setting. In order to estimate uniaxial compressive strength, index-to-strength conversion factors are used. More than 25 individual test results, from sliding site, were used in the study. Rock lithologies were classified into general categories and conversion factors were determined for each category. This allows for intact rock strength data to be made available through point load testing for numerical geotechnical analysis and empirical rock mass classification systems. The point load test (PLT) is an accepted rock mechanics testing procedure used for the calculation of a rock strength index. This index can be used to estimate other rock strength parameters. The focus of study is to correlate the point load test index ( $Is_{50}$ ) with the uniaxial compressive strength (UCS), and to propose appropriate  $Is_{50}$  to UCS conversion factors for different rock samples of the sliding site. The rock strength determined by the PLT, like the load frame strengths that they estimate, is an indication of intact rock strength and not necessarily the strength of the rock mass. The values obtained from point load strength of the study area are given in the table 17.

*Determination of rock strength  
(Point Load Test)*

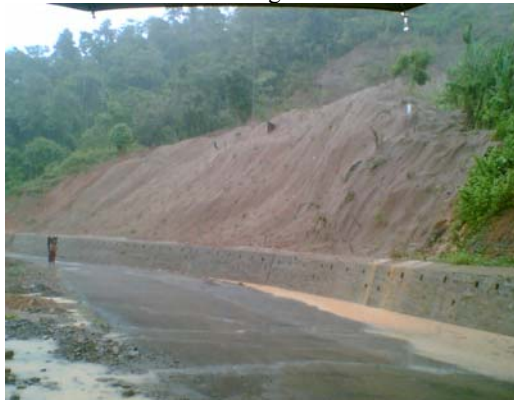
Construction of retaining wall to avoid Landslide at Awangkhul Pt. II near Army Outpost

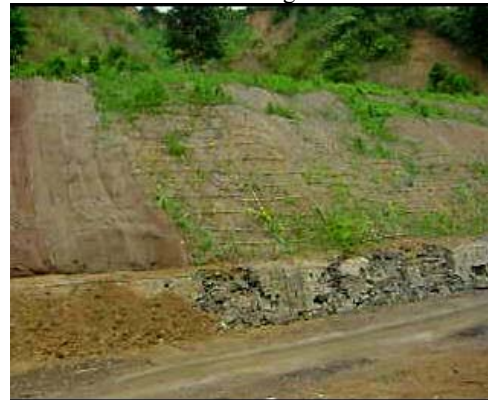
Collapse of the same Retaining wall observed
